Assessment of field installation of Clark-Drain 300SR

Two new Clark-Drain 300SR recess tray covers were fitted to access chambers (AC) located within a private driveway on a property in Skelmersdale, West Lancashire on Wednesday, January 18th 2006 by KGC Paving, a specialist contractor undertaking the driveway extension and reconstruction.

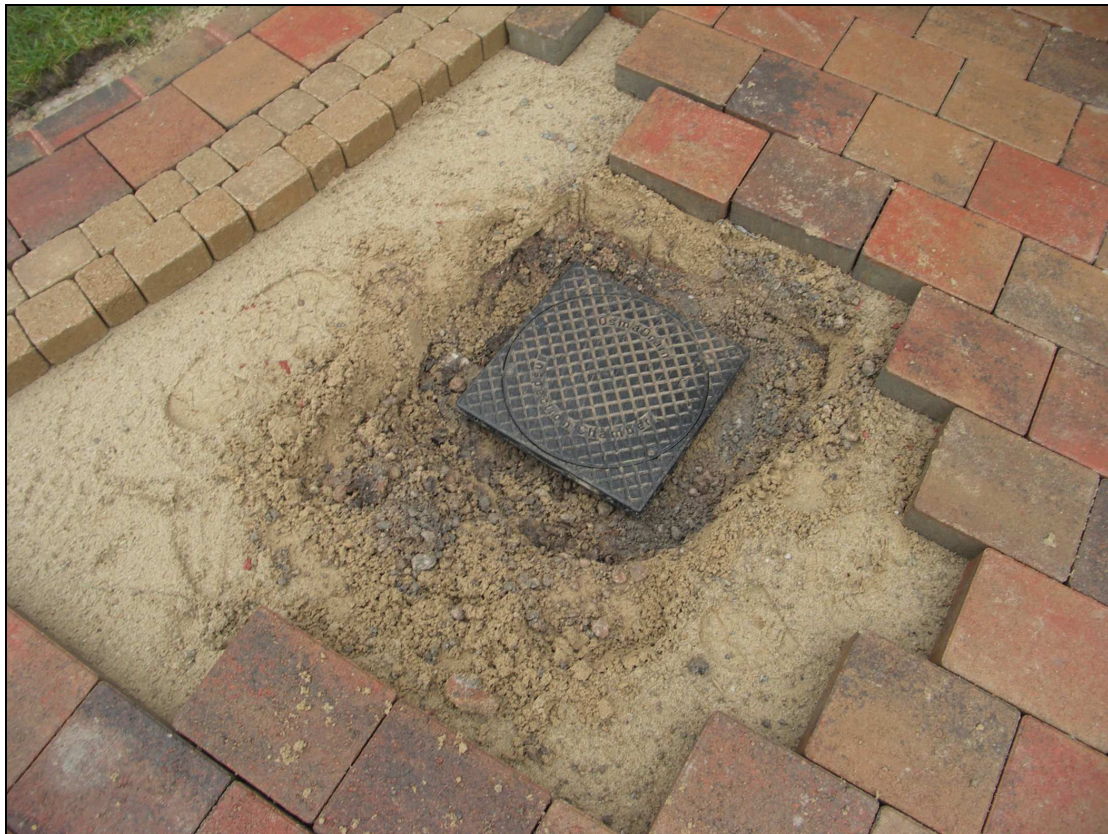
Figure 1 - AC 1 - Old cover in place

On the first AC to be fitted with the 300SR frame and cover, the chamber had previously been cut down to accommodate the previous cover at a level lower than that of the new paving. The backfill material surrounding the chamber was cleared and reduced in level sufficiently to enable the frame component to be put into position. The tray component was removed from the frame, which was then offered onto position on top of the cleared chamber. A spirit level was used to span the gap in the paving directly over the chamber and the distance between the underside of the level and the top of the frame measured to determine the amount of build-up required. This was found to be in excess of the 25mm considered to be the maximum suitable depth for an accommodation bed of mortar. (See Figures 1 to 3)

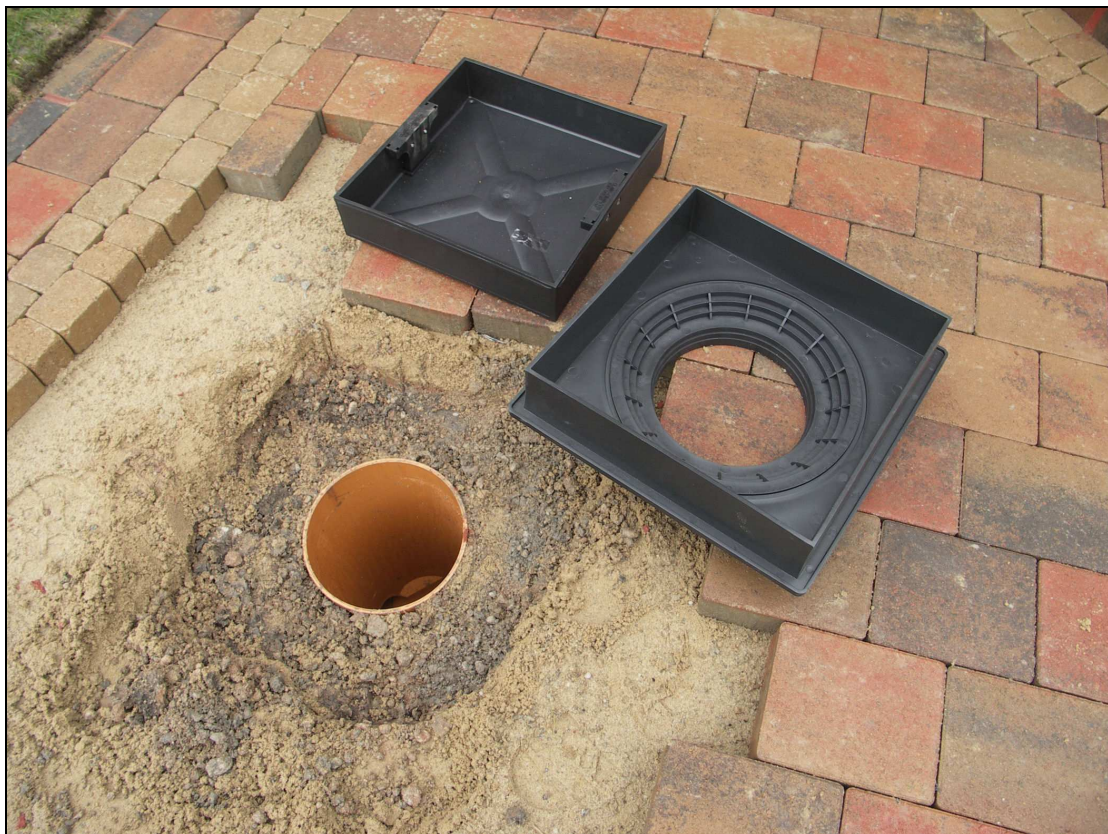
Figure 2 - Old cover removed and 300SR brought in

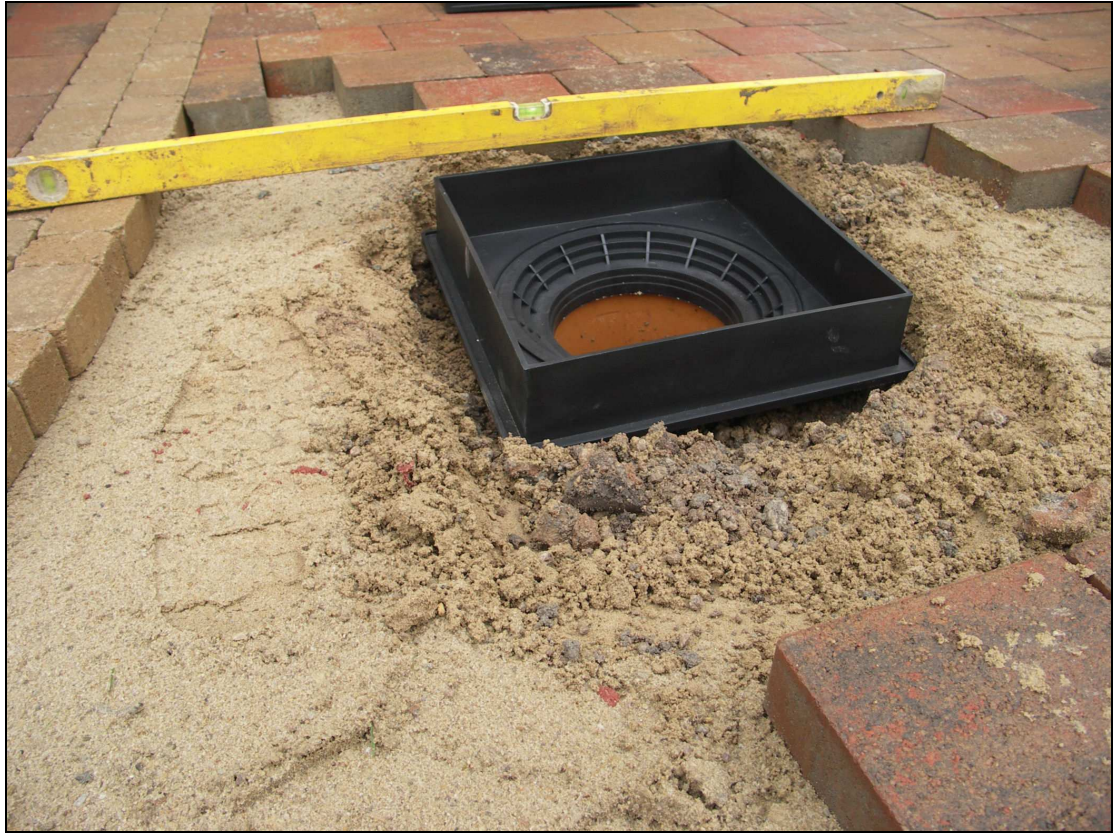
Figure 3 - Testing level of cover

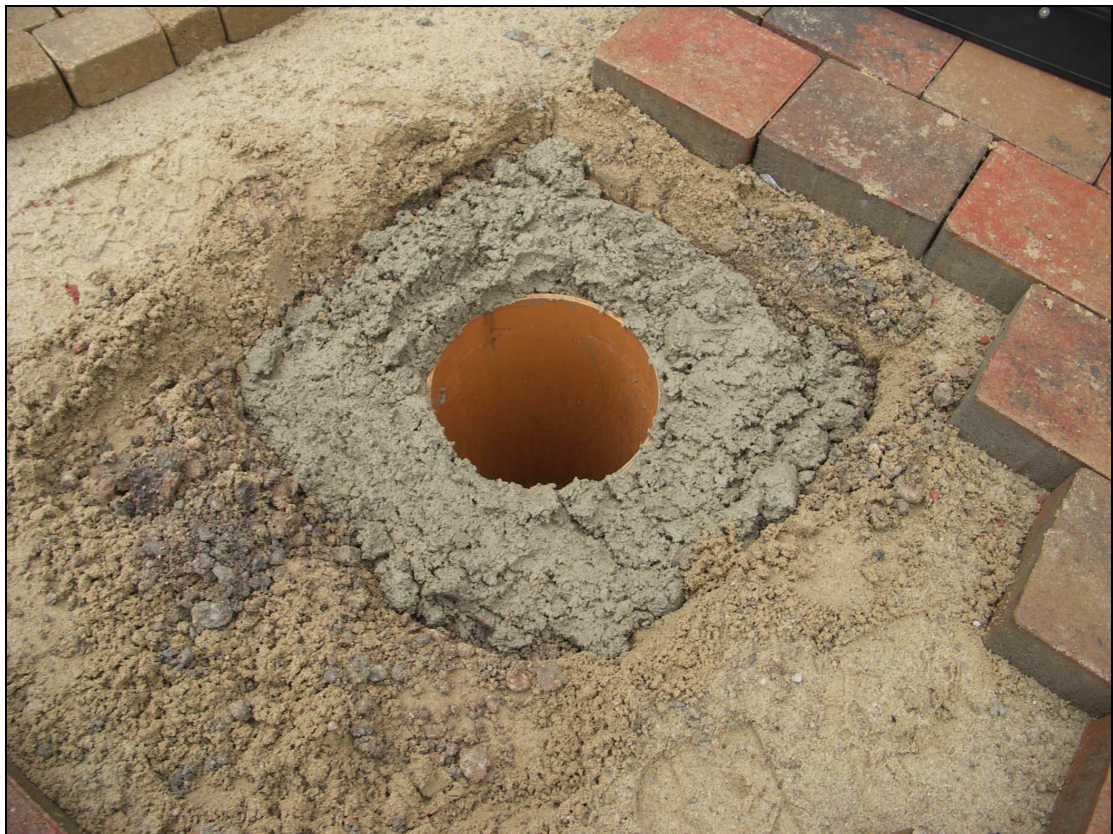
Figure 4 - First bed of mortar

A Class II mortar (3:1) was prepared and a bed of approximately 15mm depth was placed around the chamber, directly over the well-compacted backfill surround. A layer of concrete shims were then pressed into the mortar to build-up the level to approximately 10mm beneath the required bed level for the 300SR frame. A further bed of the Class II mortar, approximately 15mm depth, was then placed over the concrete shims, and the frame bedded onto it. (See figures 4 to 6)

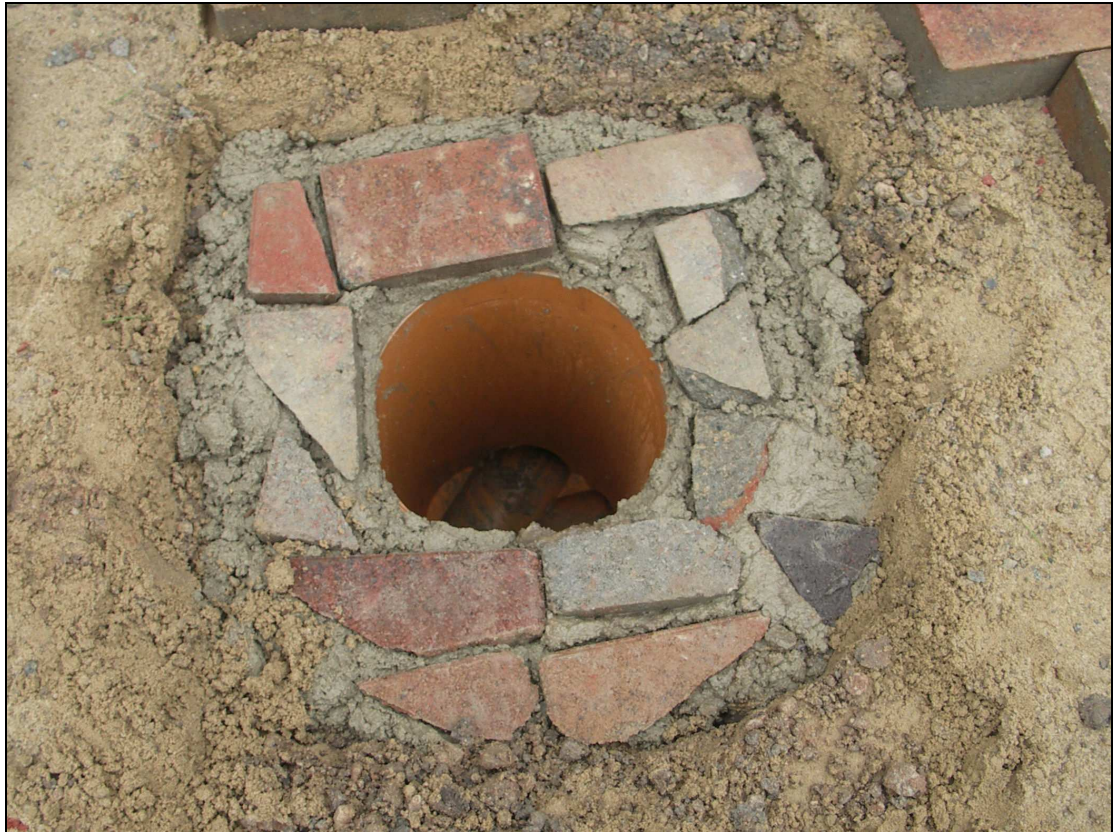
Figure 5 - Concrete shims laid onto mortar bed

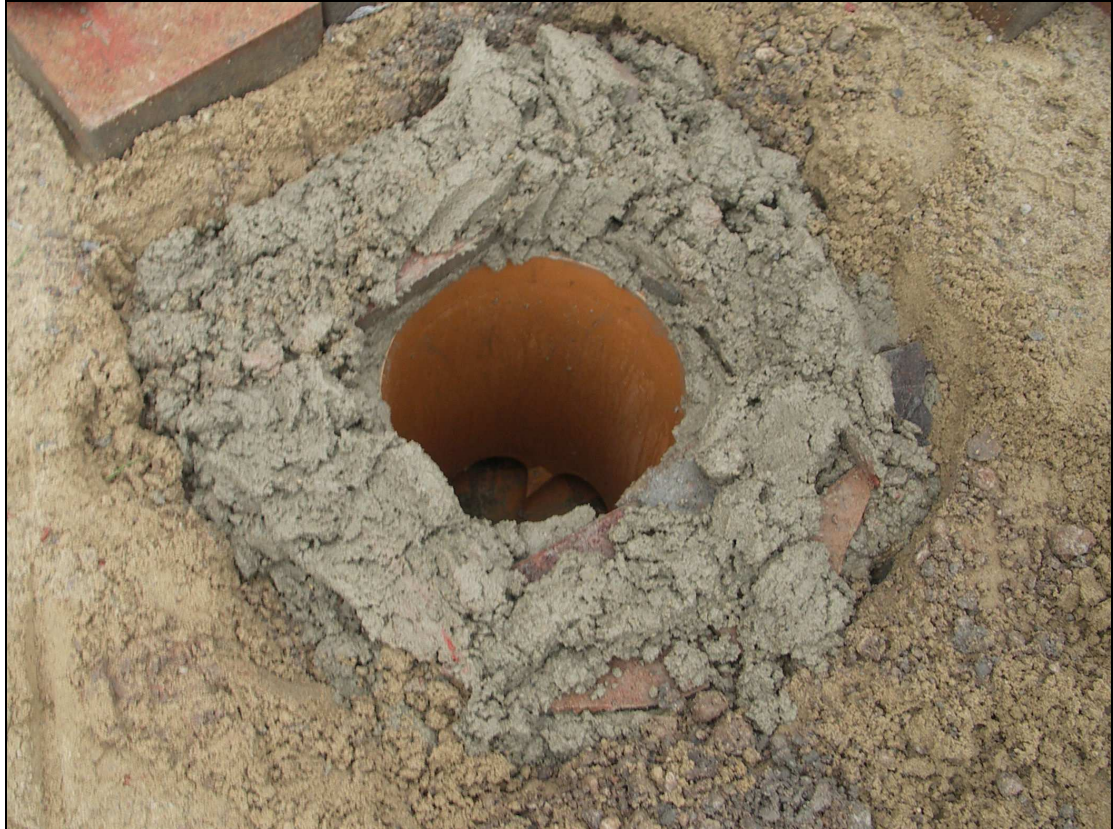
Figure 6 - Second layer of mortar

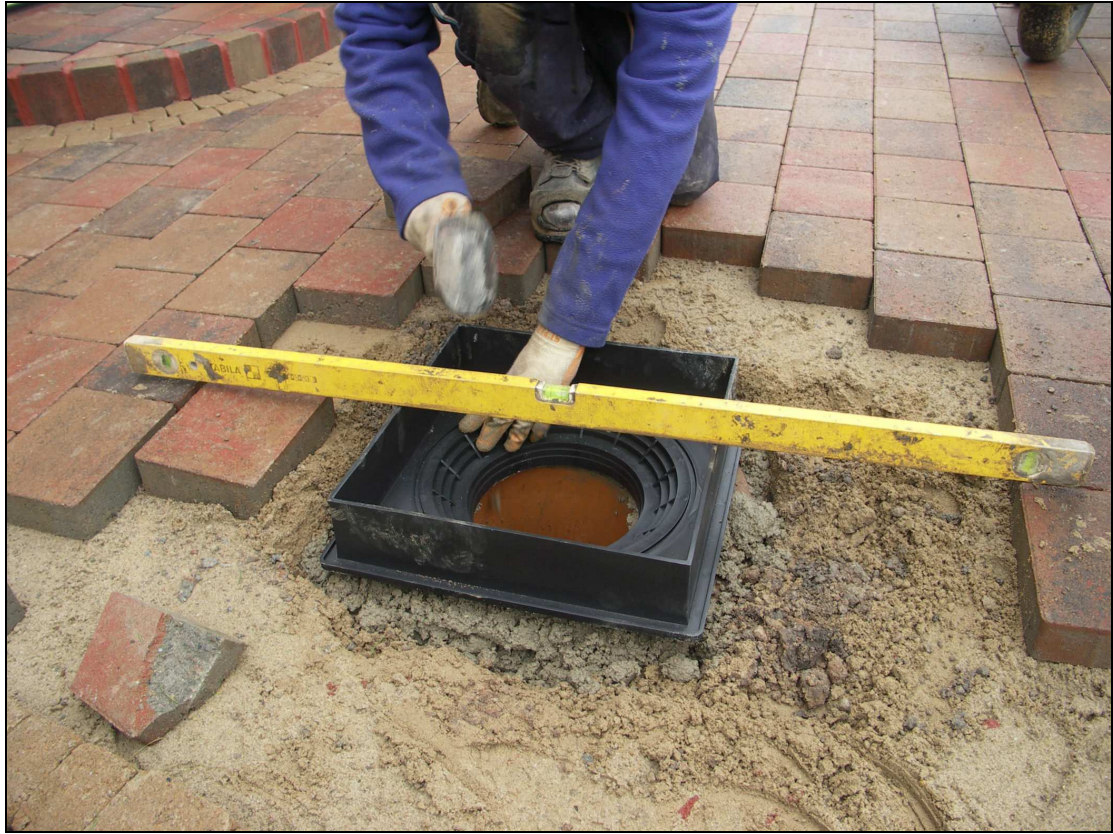
Figure 7 - Place frame and set to level

When placing the frames, a spirit level was used as a guide, with the frame being tapped down to the required level (approximately 6mm below the Finished Paving Level) using a rubber mallet, ensuring the frame remained square with the paving layout. (See figures 7 and 16)

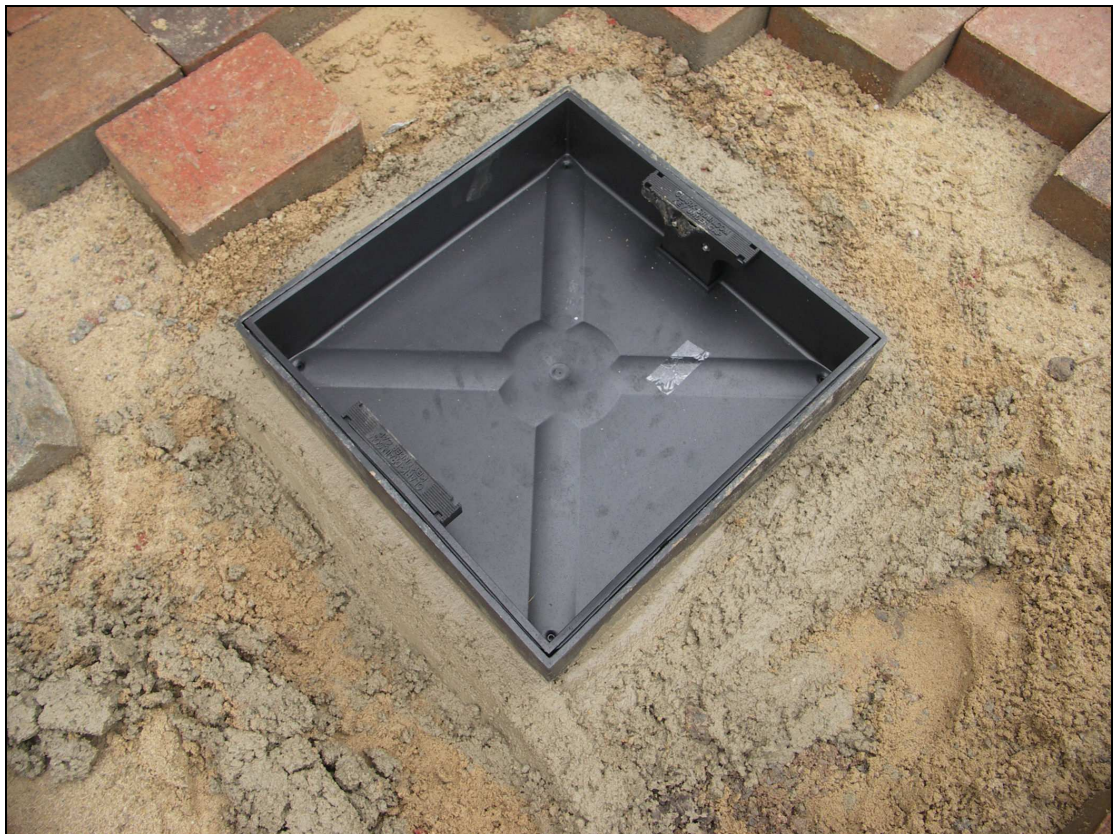
Figure 8 - Tray placed in frame

Once the frame was correct in both position and level, it was haunched in position by placing additional mortar around the external edges, bringing the mortar over the base flange in the process. (See figures 8 and 17)

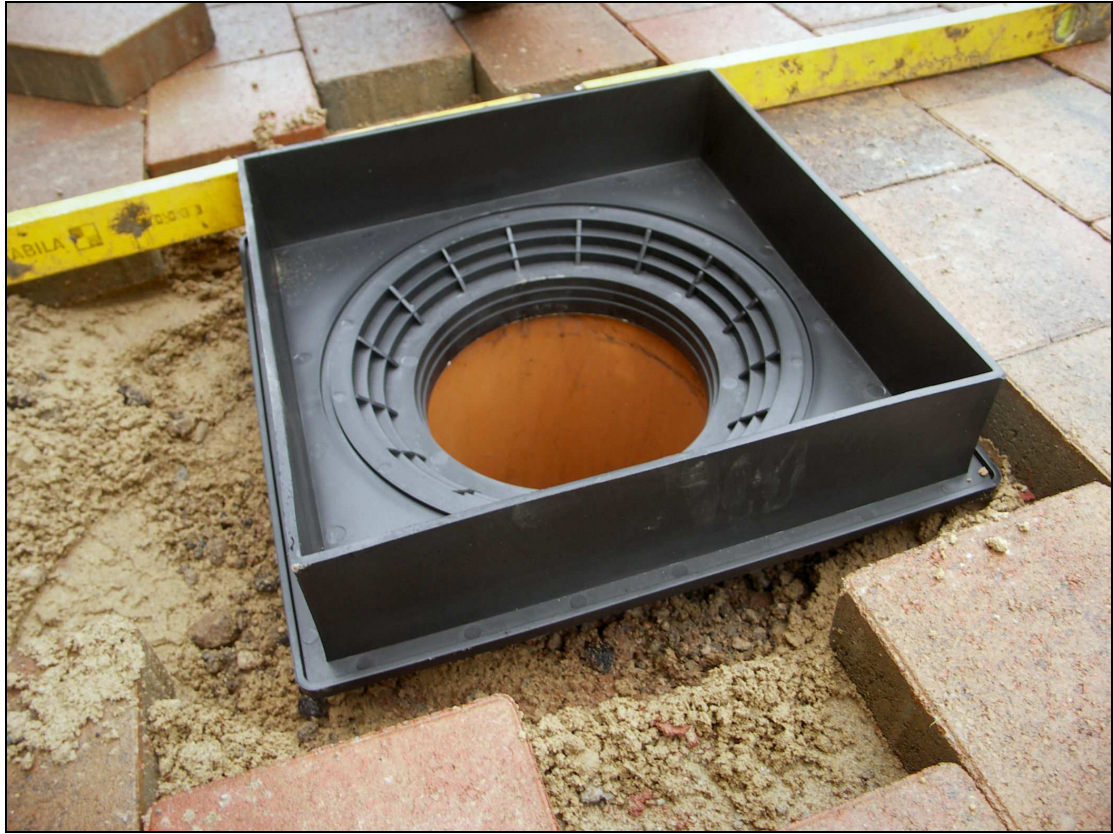
Figure 11 - Testing frame for level

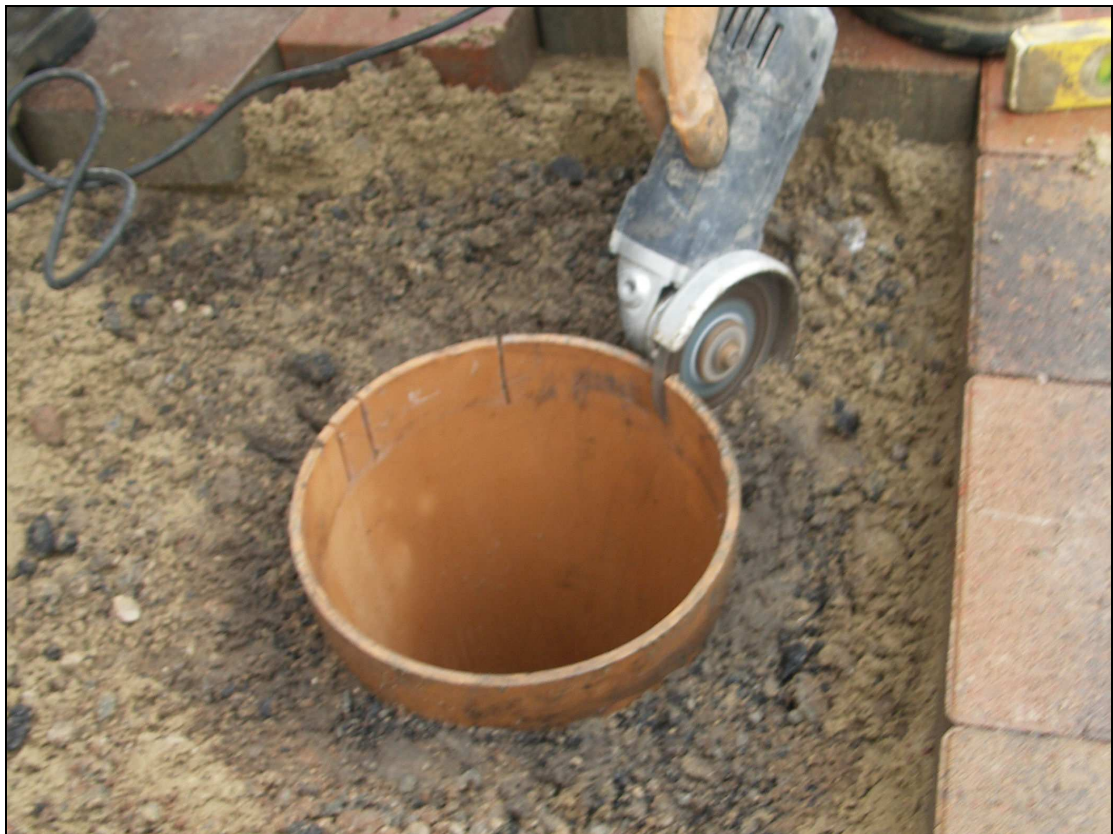
Figure 12 - Making vertical cuts in chamber wall

For the second AC, the chamber was high, relative to the required level, and so it was necessary to cut down the chamber to accommodate the frame component. As before, a spirit level was used to span the gap in the paving around the AC, and the distance between the underside of the level and the top of the chamber was measured. The chamber could then be cut down to the required level using an angle grinder. Vertical slots of the calculated depth were cut into the chamber wall at regular intervals and then a series of horizontal cuts were created to join up the slots and thereby reduce the chamber as required. (See figures 12 to 14)

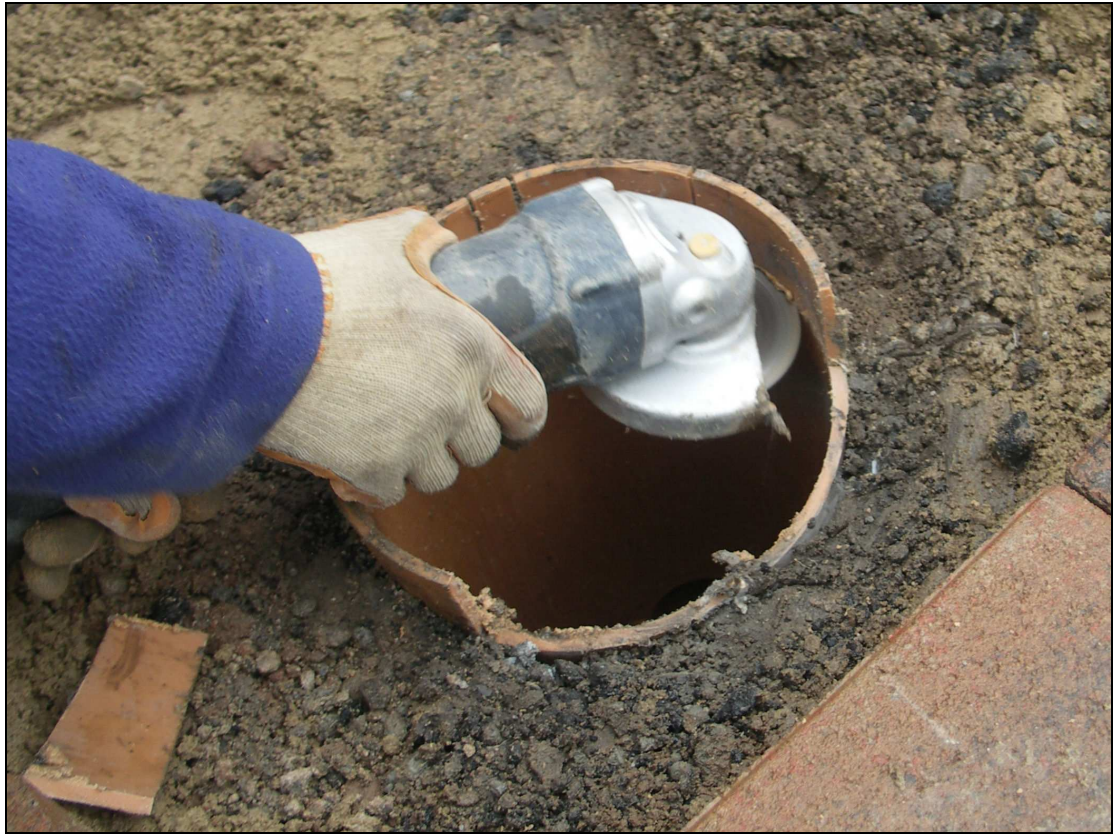
Figure 13 - Making horizontal cuts in chamber wall

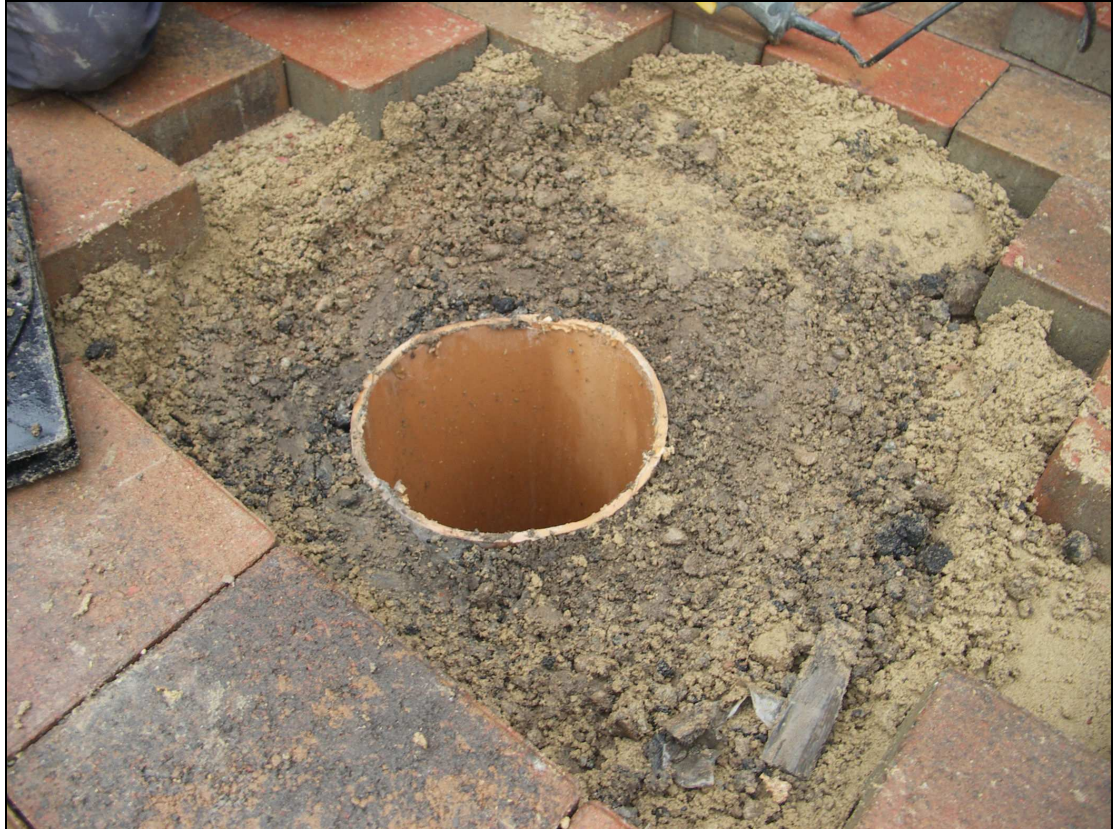
Figure 14 - Chamber reduced to formation level

When reduced, the top of the chamber was 10mm lower than the underside of the frame when in position: this would be used to accommodate the bedding mortar.

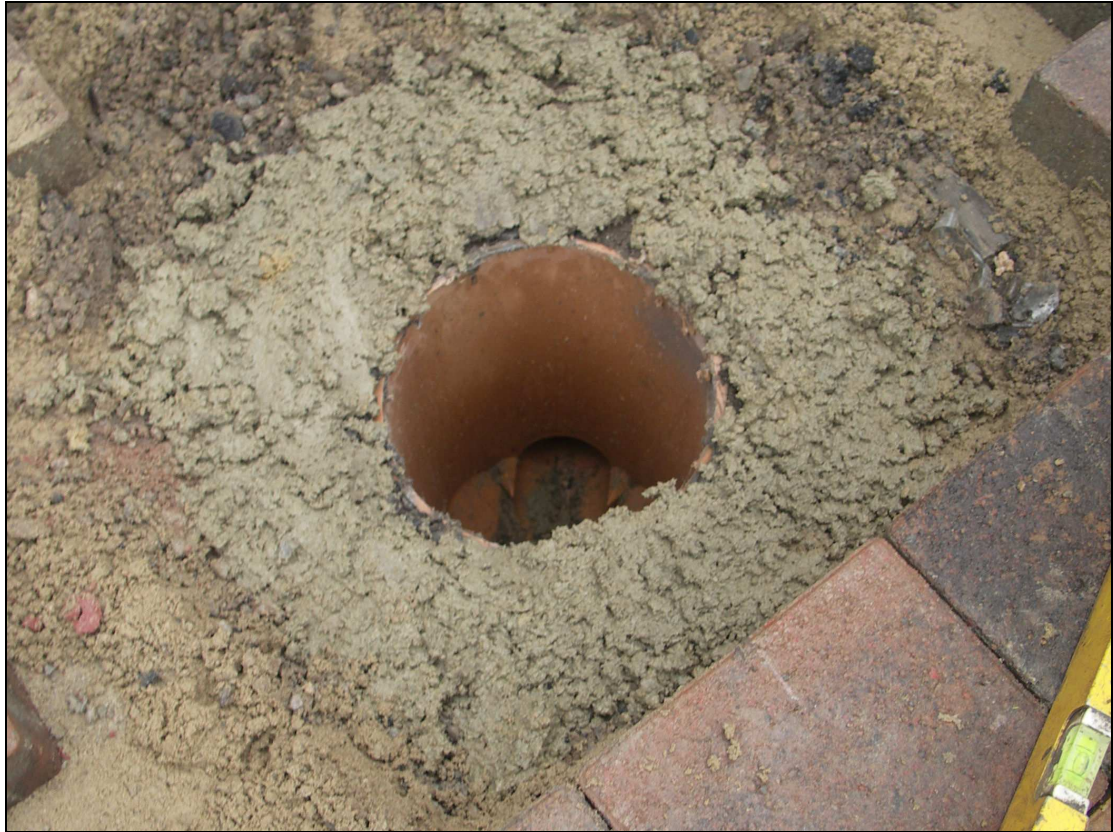
Figure 15 - Mortar bed for Frame

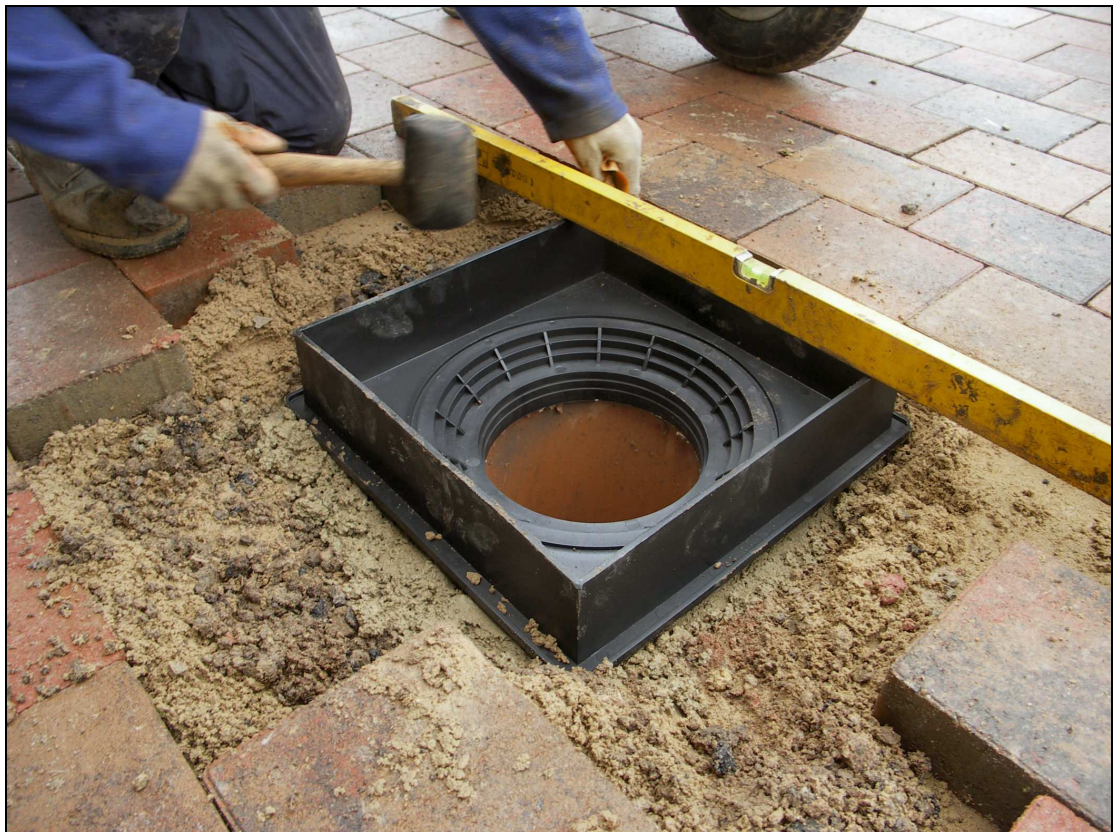
Figure 16 - Tapping down frame to required level

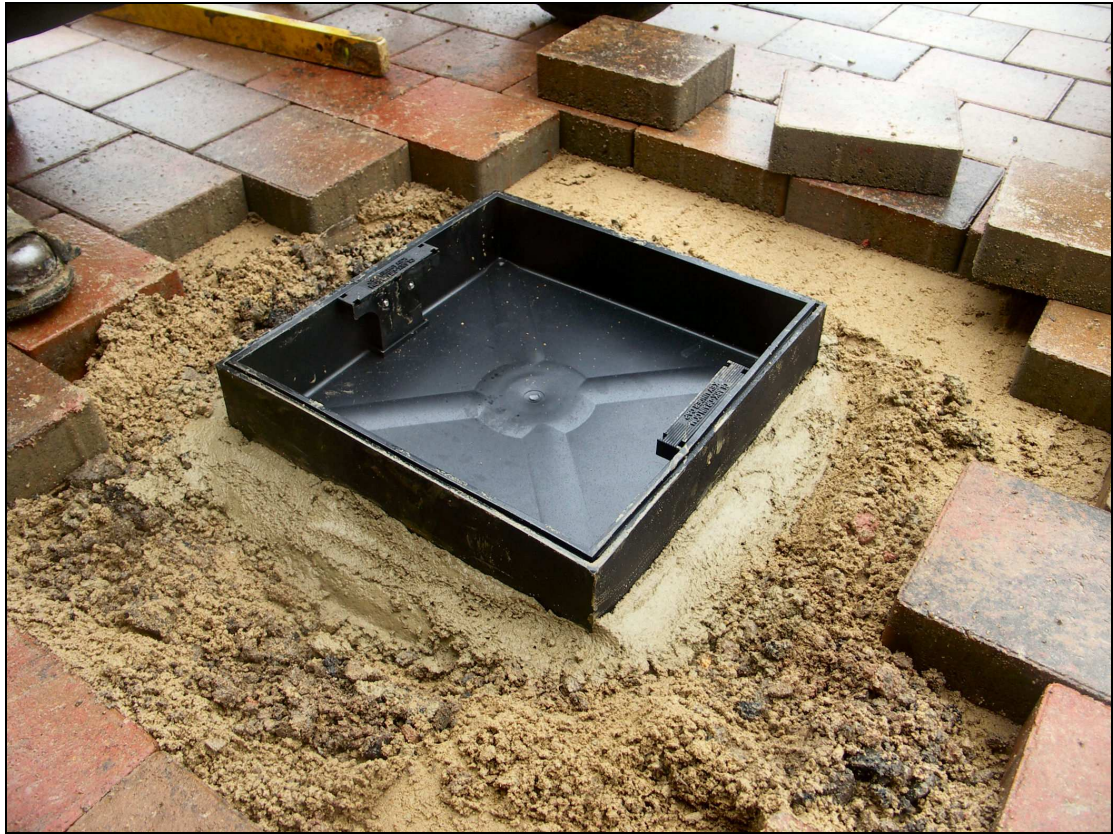
Figure 17 - Tray placed into frame

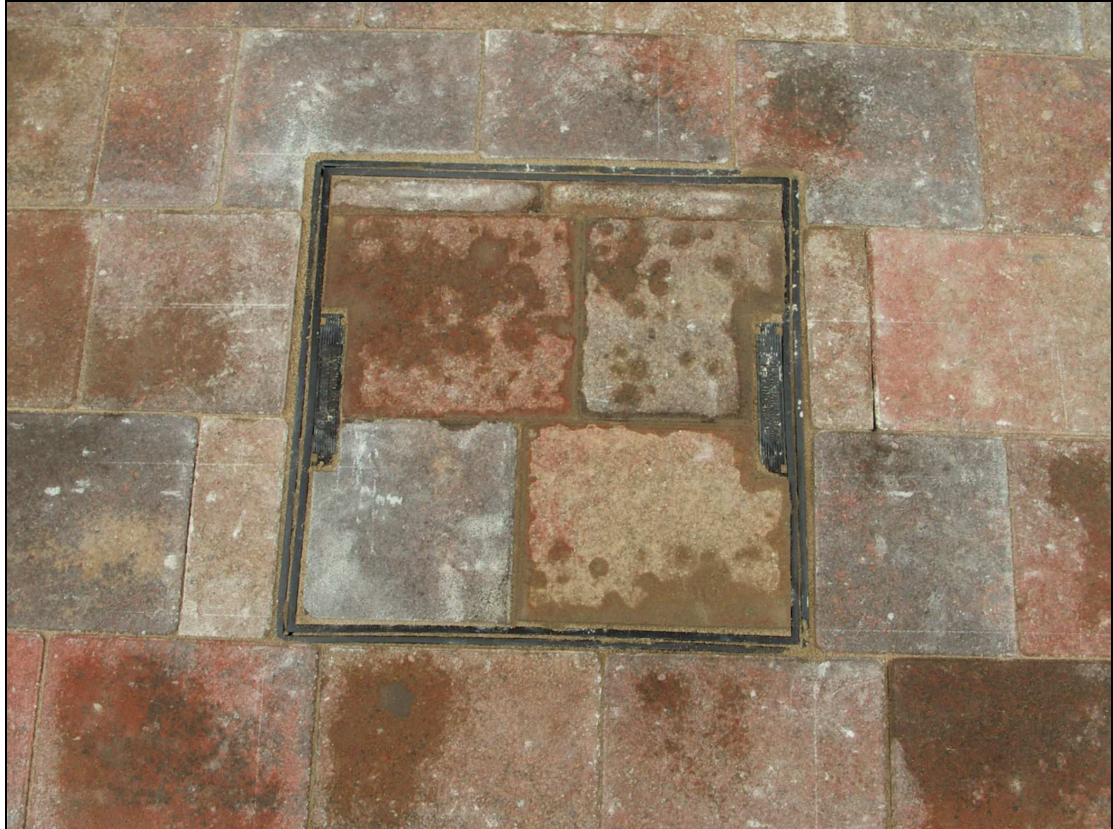
Figure 18 - Cutting-in completed

The paving used on this project (Toberore Shannon in Heather colour) was laid as transverse broken bond coursework and so the frame and tray had been aligned square to the coursework. This ensured all cut blocks were similarly "square" and no acute-angled cuts were required. (See figures 18 to 20)

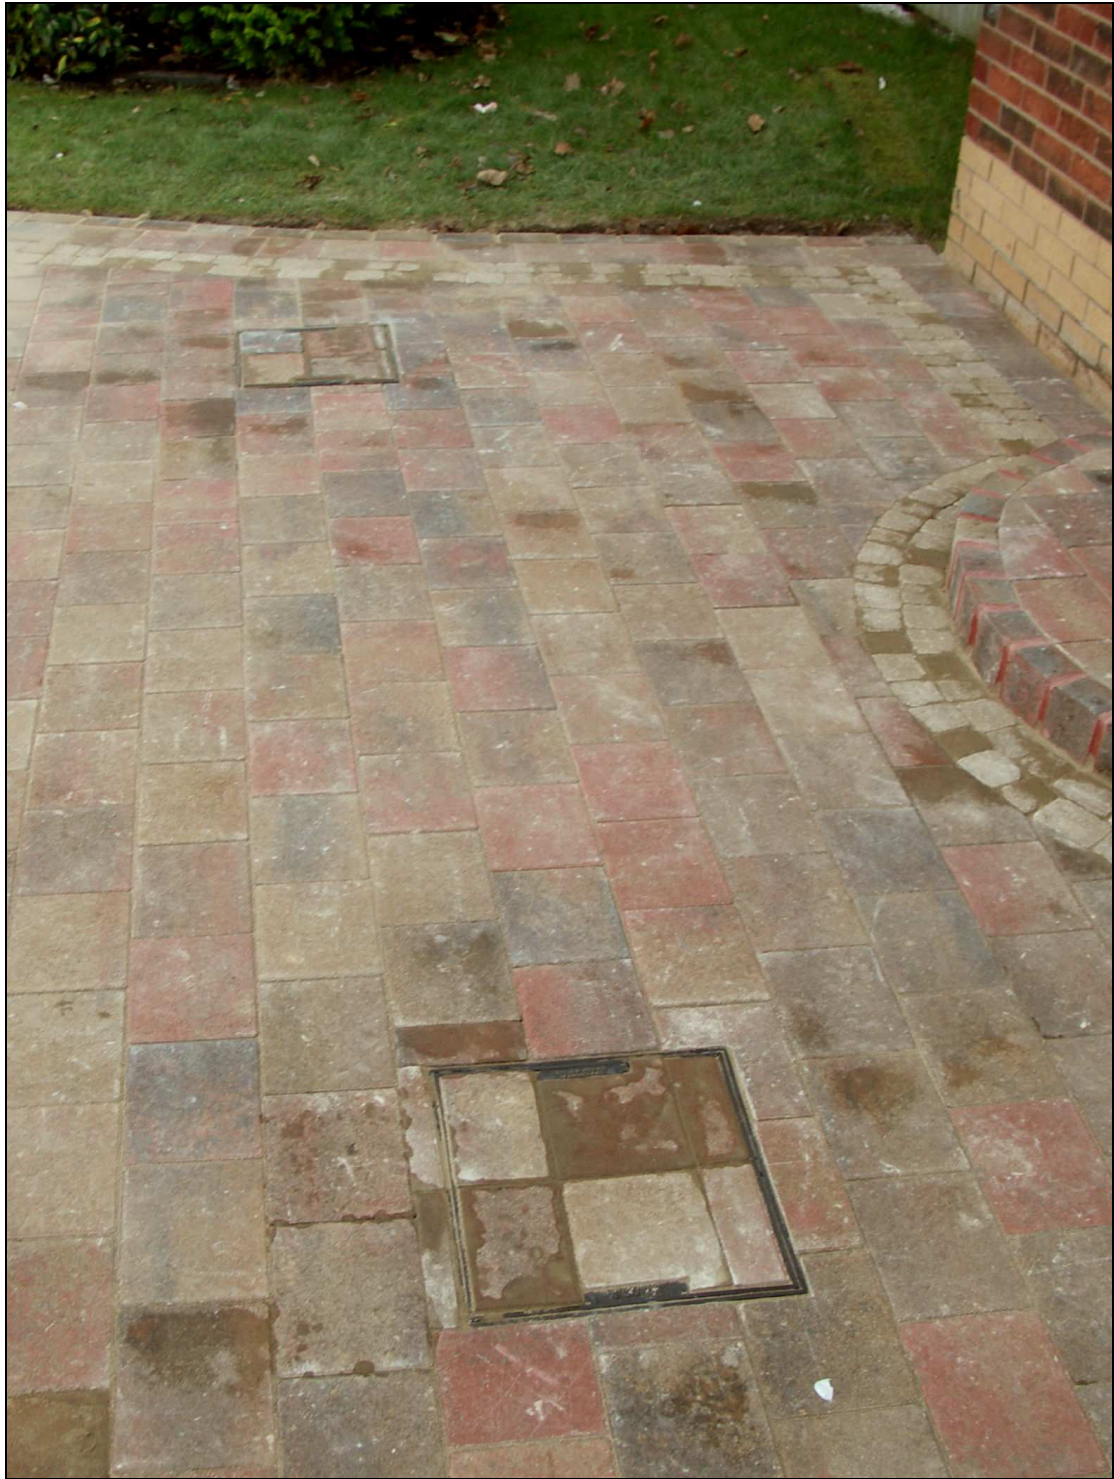
Figure 19 - AC1 (top) and AC2 completed

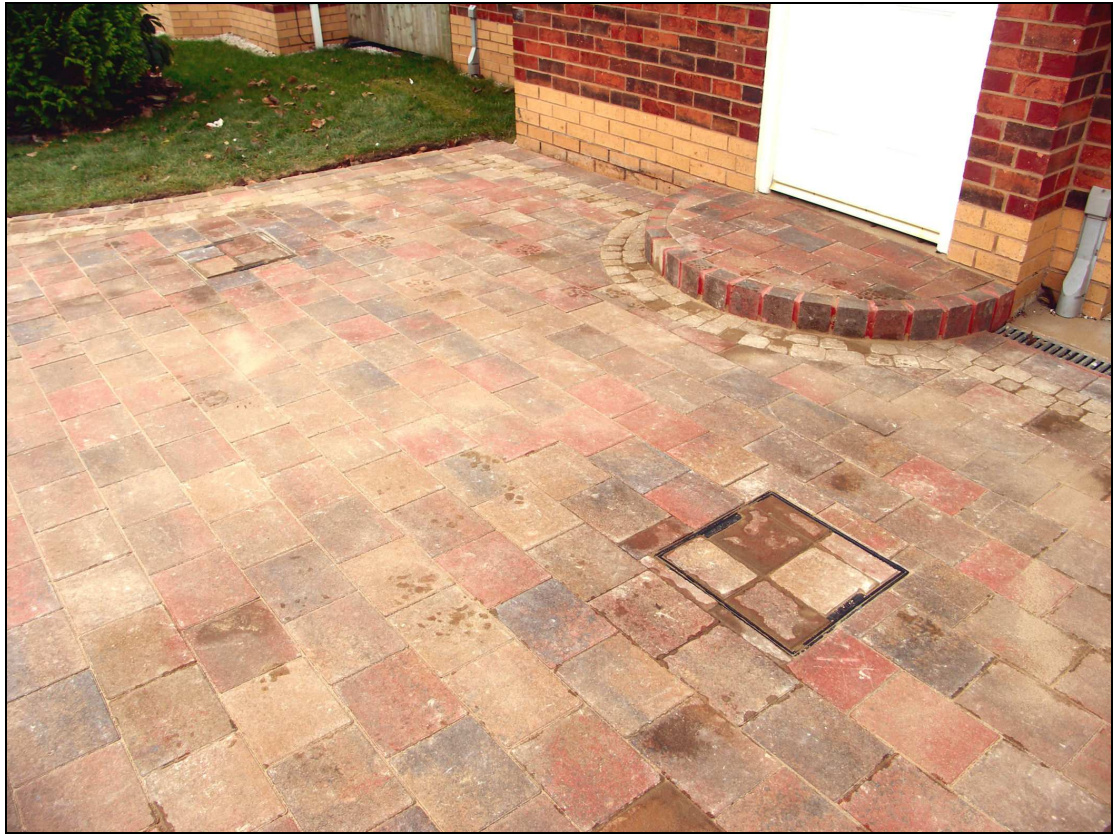
Figure 20 - Two covers completed and in place

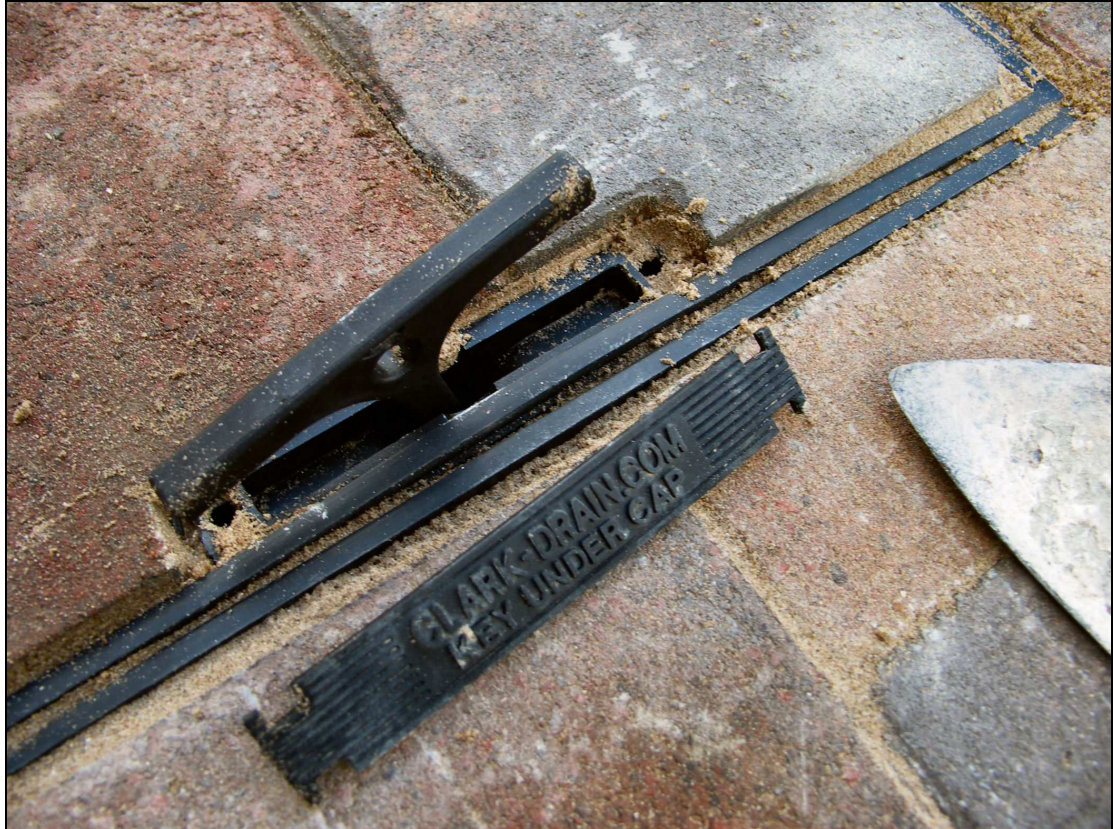
Figure 21 - Testing integral key

On completion of the cutting-in, the whole pavement was jointed with kiln-dried sand and then consolidated (referred to as "wackering" in the Clark-Drain guidance sheet) using a vibrating plate compactor. Following consolidation, the surplus sand was swept off the pavement surface and the Clark-Drain fittings were examined. The integral keys were extracted to check that they had not become jammed with the jointing sand, and the trays were lifted out. Very little sand had found its way into the integral key block and the keys could be extracted without any difficulty. A small amount of sand had been vibrated into the joint between tray and frame although this did not impede this initial removal. The extraneous sand was removed from inside the frame using a fine brush and the tray was replaced. (See figure 21)
